Circle Lake: One fix, two properties

COVID-19 put many conservation projects on pause. Rice SWCD staff weathered change orders, material shortages and price fluctuations to respond to a request from neighbors. Water quality will benefit from landowners' work supported by the lake improvement district. It's one step toward big-picture goals.

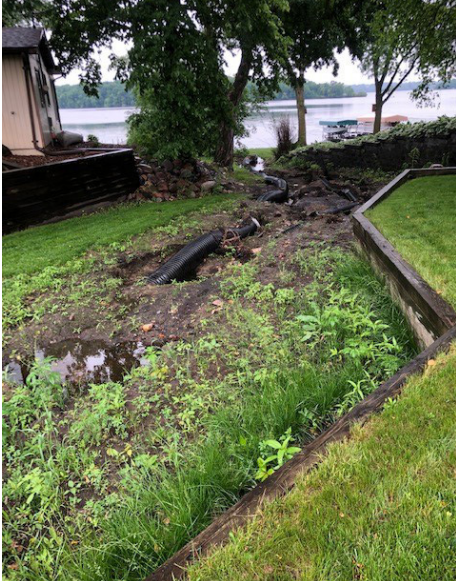
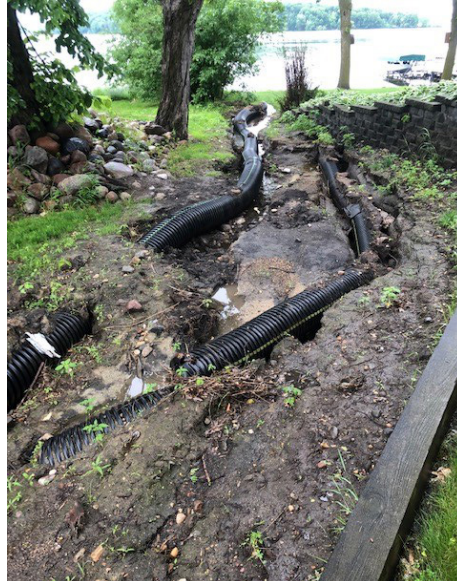
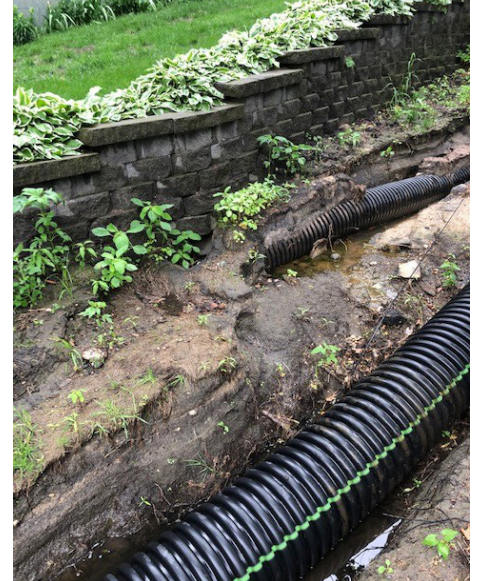
BEFORE: The worsening gully between neighboring properties on Circle Lake southeast of Lonsdale is shown on June 21, 2019. Landowners worked with Rice SWCD staff and Southeast SWCD Technical Support JPB staff on a solution. To fund the work, the SWCD used local capacity dollars — provided by Clean Water Funds from BWSR — and matching dollars from the landowners and the Circle Lake Improvement District.

The land around the drainage tile continued to erode, forming a gully between the Streiff and Cook properties. Sections of the tile were missing or not reinforced.

While both landowners had attempted to stabilize the gully, the erosion continued, and mini sinkholes continued to form. Eventually, the draw between them deteriorated

to the point where the retaining wall on Cook's property and sediment along both yards were washing into the lake. The gully was more than they could repair. A landscaper fixed the site, but subsequent rains washed away the repairs.

Nelson described a sediment plume of soil that entered the lake. Led by Nelson, the JPB determined the best option was to replace the failing tile.

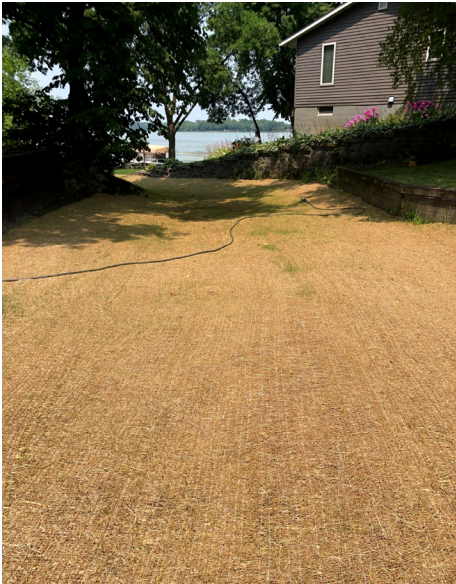
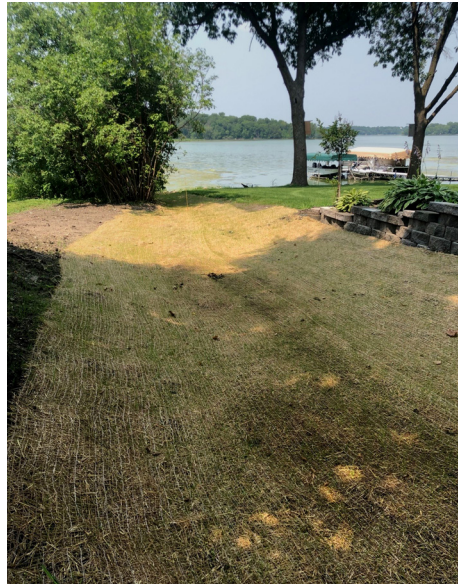
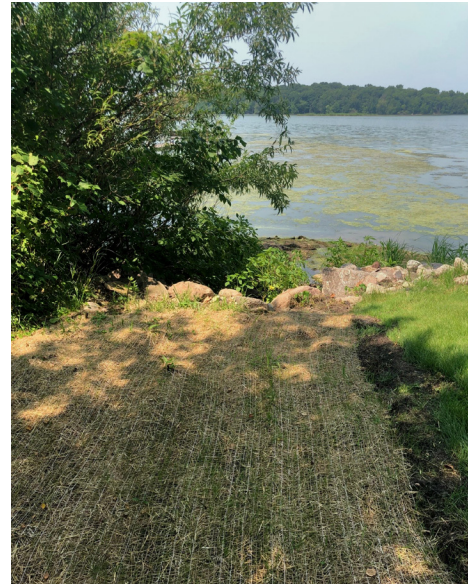
AFTER: The completed project, seen here on July 21, 2021, incorporated new tile and a regraded slope covered by erosion control fabric made of jute. It will keep an estimated 2.1 tons of sediment and 2.1 pounds of phosphorus out of Circle Lake each year.

The project's estimated annual pollution reductions include 2.1 tons of sediment and 2.1 pounds of phosphorus. It's estimated to curb soil erosion by slightly more than 6 tons a year.

re-bid. Ultimately, the landowners selected a new contractor. The new design incorporated materials that were more readily available and reasonably priced. Nelson reduced the scope of the project, resulting in fewer, more heavily reinforced joints. New materials connected to existing systems. The redesign met the USDA's Natural Resources Conservation Service (NRCS) specifications.
